Technical Report 260

**FIELD TEST OF A MESL  
(Membrane-Enveloped Soil Layer)  
ROAD SECTION IN CENTRAL ALASKA**

**July 1975**

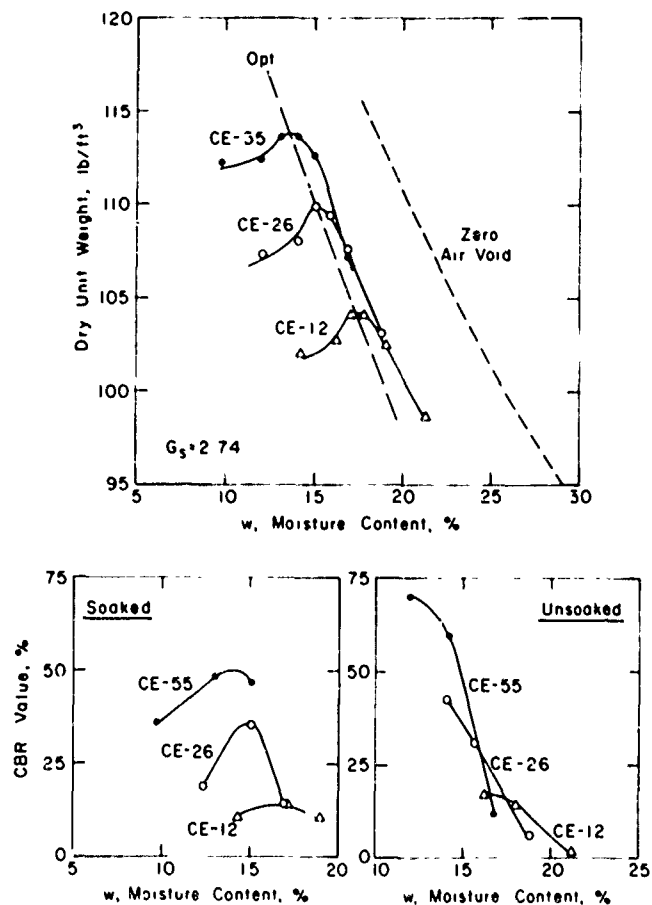
Figure 3. Silt compaction and CBR versus moisture content.

The compaction curve for the embankment silt (Fig. 3) indicates the CE-12 optimum to be 104.0 lb/ft<sup>3</sup> at 17.5% moisture content (all values presented here are recorded in Table I). The field compaction test on the first lift of silt gave values of 99.5 lb/ft<sup>3</sup> and 16.9% moisture, and soil cores taken after construction showed that the silt moisture content averaged approximately 13.1%. Consequently the field compactive effort approximated densities in the order of 96% of the CE-12 compaction test. The lower than optimum in-place moisture content of the MESL is believed to be an even more important requirement than achieving optimum density for maintaining the soil strength in frost areas to minimize or prevent moisture migration during freezing.

As a matter of necessity, the use of fine-grained materials as structural layers requires the prevention of moisture absorption to maintain strength. Evidence of this is shown in Figure 3 with the plotted results of the soaked and unsoaked C<sub>u</sub>R values and molded moisture contents. The soaked samples show a large decrease in the CBR values for molding moisture contents above and below the optimums. Figure 12 shows the general increase in moisture content within the MESL between August 1970 and April 1972 at stations 1+00 and 2+40. Moisture contents at station 2+40 tended to average slightly above the 17.5% CE-12 optimum level with a maximum value of 23.2% at a depth between 8 and 12 in. The moisture content in the vicinity of station 1+00 also showed an increase in this

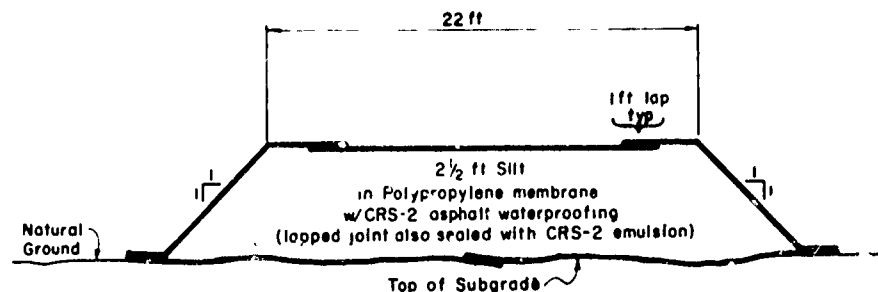
Figure 4. Typical cross section of MESL.

Surface elevations taken before and after the construction of the MESL show a compacted silt thickness range of 0.31 ft at station 0+00 to 2.96 ft at station 2+40. The average depth of the silt layer measured at stations 20 ft apart was 2.02 ft. Figure 4 shows a typical cross section of the MESL (at about station 2+00), and Figure 5 shows the centerline profile of the silt layer. The thermocouple assembly shown at station 2+41 of Figure 5 was installed in September 1971 to a depth of 9 ft; it has 12 temperature observation points.

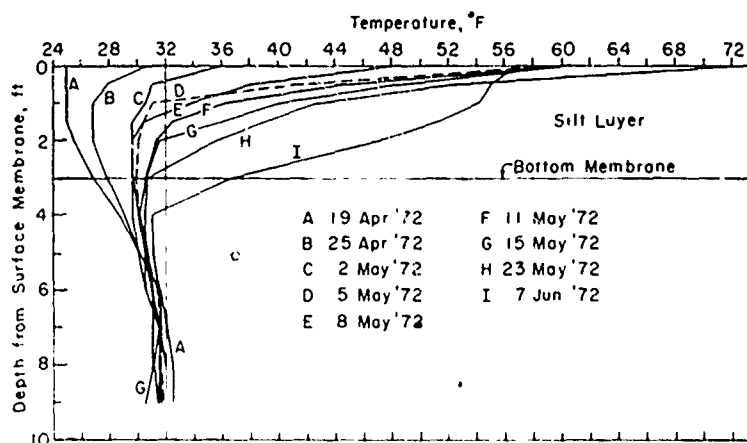
The temperature gradients in Figure 9 show the thaw progression more closely during the May 1972 traffic tests. From interpolation of the thermocouple readings, thaw of the silt embankment began on 27 April 1972, and reached the 3-ft depth approximately one month later. Therefore, when the May 1972 traffic passes were started, the thaw had progressed about 1 ft into the top of the MESL.

Figure 9. Temperature gradients in MESL during thaw-trafficking at station 2+41.

Benkleman beam tests were performed on the MESL upon completion of the May 1972 tests. At that time, thaw had progressed about 2 ft down into the MESL (Fig. 9). The traffic test vehicle deflections on the left track varied between 0.021 and 0.286 in. The right track deflections were considerably greater, ranging from 0.045 to 0.429 in. As might be expected, the highest deflection in each wheel track occurred in the area of greatest rutting—specifically, the 0.429-in. deflection occurred in the right wheel track near station 0+60, and the 0.286-in. deflection occurred in the left wheel track near station 1+15. The results of these tests are given in Table II. The standard axle loading for Benkleman beam testing on permanent roads is 18,000 lb. Trucks presently in the military inventory were used for these tests to obtain data for seasonal comparisons only.

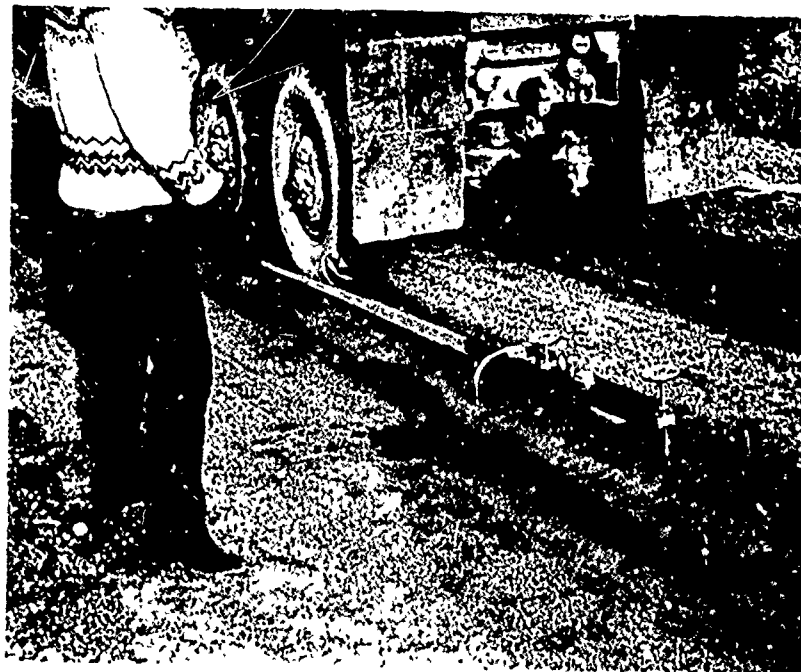
Before significant traffic had occurred on the MESL section, Benkleman beam tests were run on it in early October 1970 (Fig. A20). With a 10-kip per axle, tandem-axled, single-wheeled dump truck moving along the section, wheel track deflections of 0.022 to 0.042 in. were observed. The tests were conducted again with a 9.4-kip axle load on the same truck in May 1971 (Fig. A21) and the deflections ranged from 0.012 to 0.024 in. Even though some frost had entered the ground before the October test, and the surface of the MESL had thawed slightly before the May 1971 deflection tests, the data show that the section behaved more like an unfrozen section in October, and more like a frozen section in May. These small deflections show that the section had not noticeably deteriorated with freezing and thawing during the first season. Benkleman beam data, and all other traffic data discussed in this section, are presented in Table II.

*Figure A20. Benkleman beam test on MESL during October 1970.*

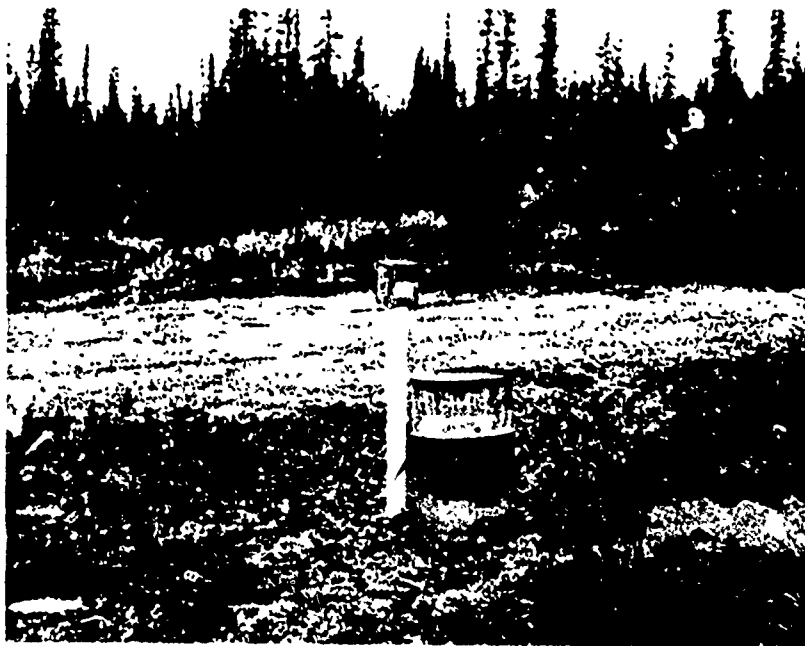
In September 1971 a thermocouple assembly of 12 points was installed at centerline (Fig. A33) to a depth of 9 ft below the MESL surface (Fig. 5). The opening in the bottom membrane was not sealed after the thermocouple assembly was installed. Readings were taken during trafficking to observe the progression of the thaw line within the MESL. Figures 6 and 7 reflect the severity of freezing and thawing which occurred in the Fair-

*Figure A33. Thermocouple switch location at north end of MESL.*
